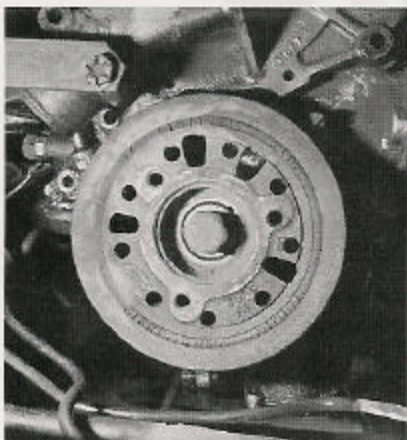
**3** Ewww. A balancer with this kind of wear can cause some serious vibration problems or worse yet, the ring can come loose and wreak havoc on a really nice engine bay. We'll contact Damper Dudes for a rebuilt damper.

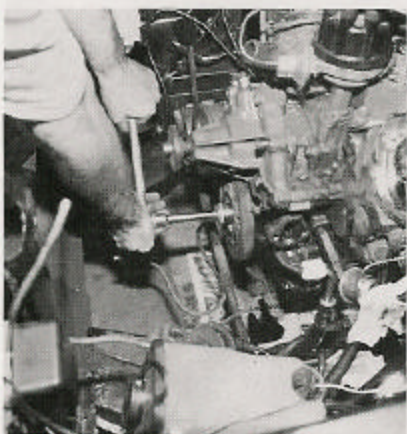
**4** Think long handle or breaker bar on the balancer bolt. If you have air tools, use the air impact wrench to get the bolt to release since engine compression may not be enough.

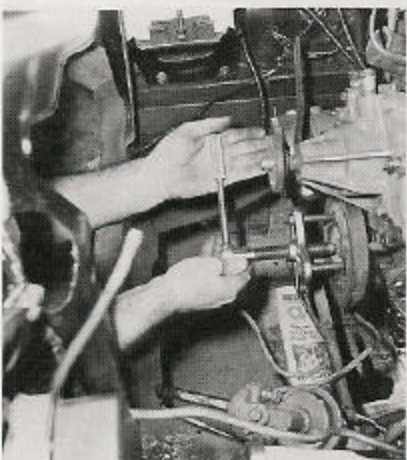
**5** Buy/rent a harmonic balancer puller to get the old balancer off. It's the only surefire way to do the job right.

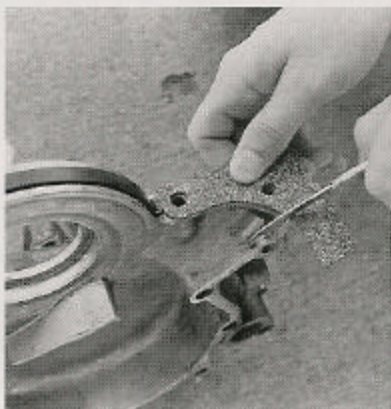
The gasket needs to be cut at the water pump housing to mate up. We still recommend replacing the crankshaft seal and the pan gasket as shown.

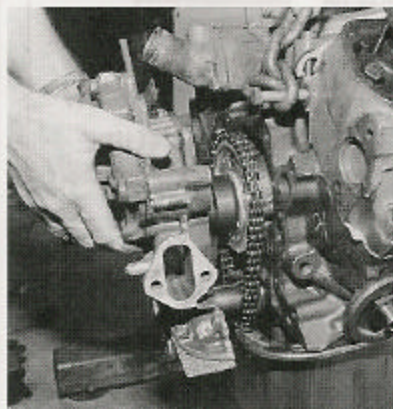
After letting the gasket seat and the RTV dry, apply a thin film of RTV to the pan and the gasket. Slide the timing cover onto the crank and you're ready to go.

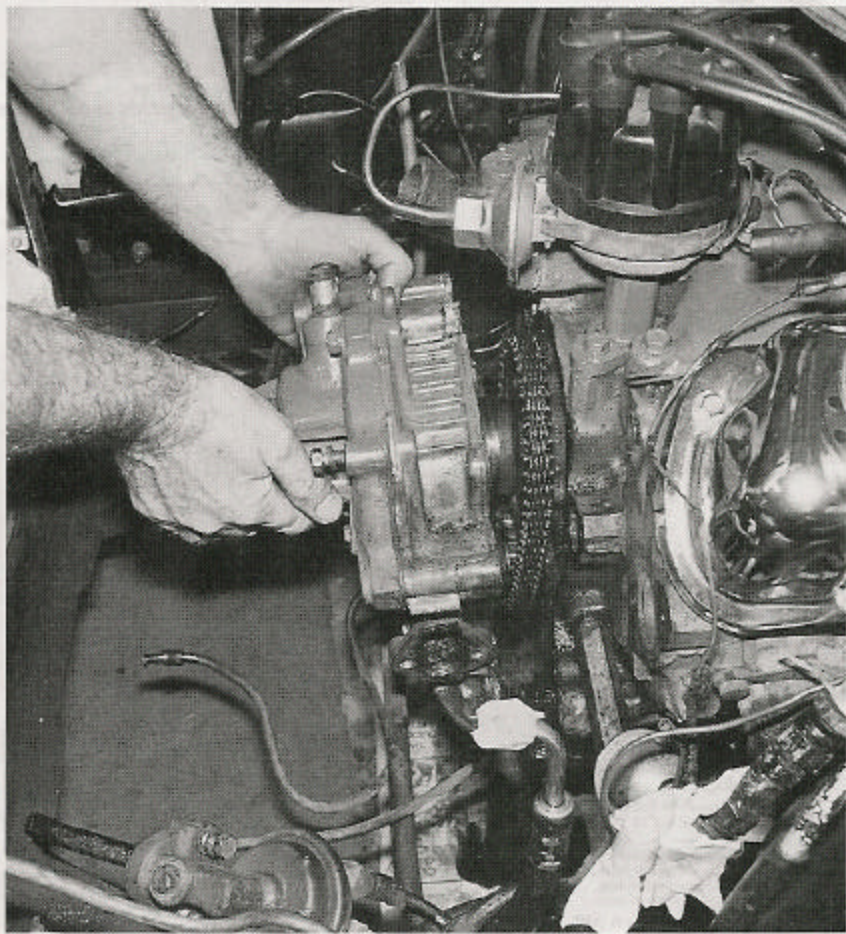
**6** Since we're not interested in replacing the water pump or its gaskets, we'll leave it attached to the timing chain cover. However, if your timing cover is bad, these are now available from most Mustang parts vendors.
